4 Point Insurance Report

This Report Has Been Prepared Exclusively For: Jim Smith
Property Address: 6664 Dallas Ave. Pensacola, FL 32526
Date of Inspection: 06/05/17 Start Time: 9:00 A.M.

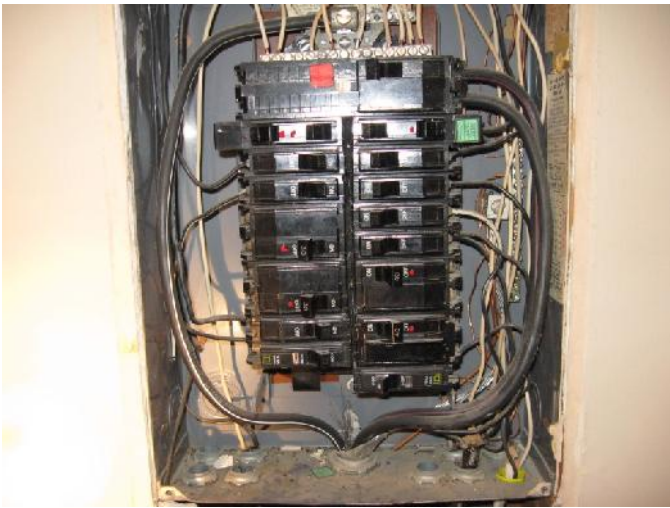
The electrical service is a 200 amp service with circuit breakers and copper branch wiring. Updates between 2005-2017 include multiple new replacement outlets & switches, new lighting fixtures / fans, and new GFCI outlets where applicable. The Square D circuit breaker subpanel and the copper branch wiring are in good and serviceable condition with an estimated remaining life of 40 +/- years.

Square D subpanel - copper branch wiring

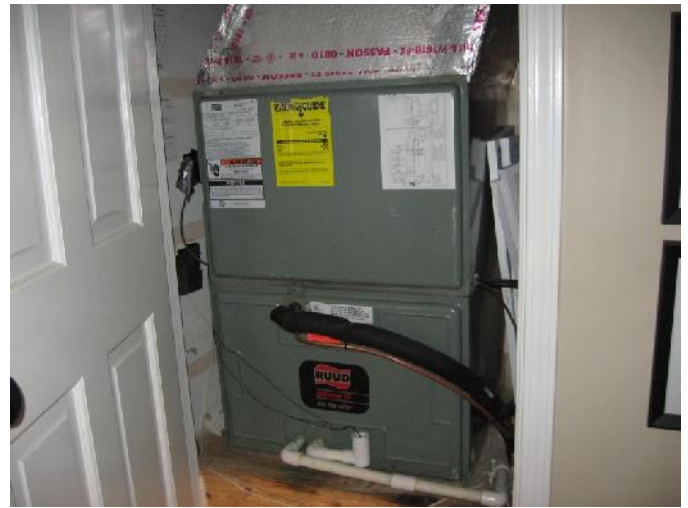
The central HVAC system is a 2006 - 4 ton electric air conditioner & heating unit. The units are in working and serviceable condition at this time with an estimated combined remaining life of 12 +/- years, assuming proper maintenance is performed.

HVAC Unit – 2006 – 4 ton

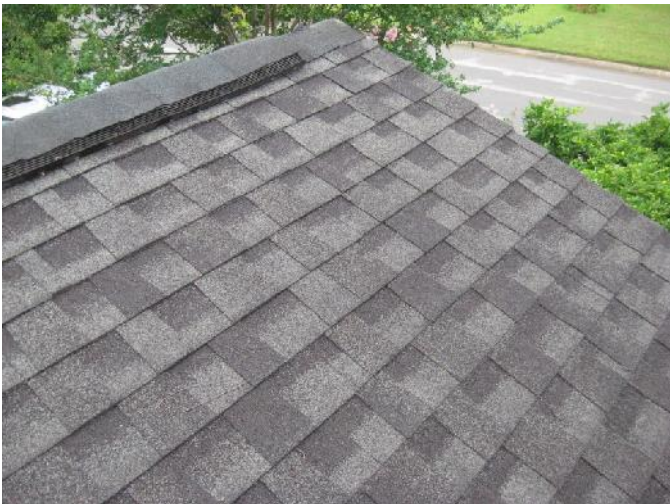
Roof View

The roofing material is a single layer composition shingle type installed on a pitched gable roof in 2005. The roofing material is in good and serviceable condition, with no readily visible leaks observed. The roofing material has an estimated remaining life of 15 +/- years, assuming proper maintenance is performed.

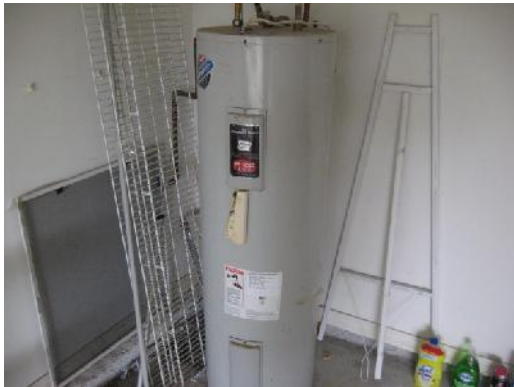
Water service piping where viewable is copper piping. No leaks were observed. Updates include various new kitchen and bath faucets / fixtures between 2005-2017, and a new electric water heater in 2005. Any observable repairs to the original plumbing system have been done with newer materials. The plumbing is in good and serviceable condition with an estimated remaining life of 40 +/- years.

Electric Water Heater - 2005

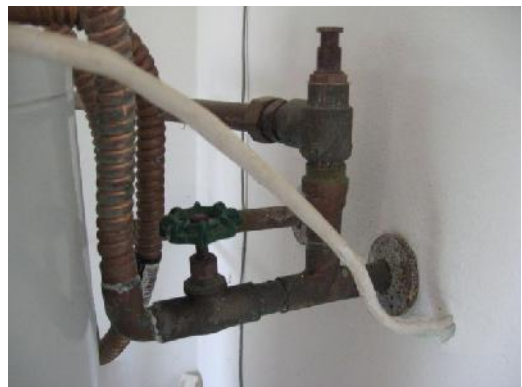
Copper Piping
