Inspection Report
2215 Grande Ave.
Pensacola, FL
Prepared for:
Greg & Lisa Sample
06/03/17

RE: 2215 Grande Ave.
Pensacola, FL

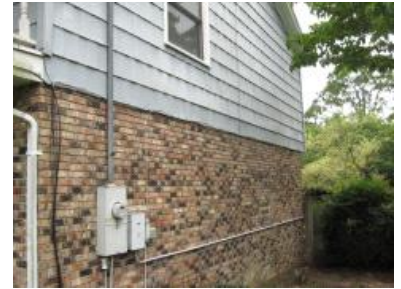
MATERIAL: Brick veneer & wood siding.

CONDITION: Both types are in good condition.
FRAMING MEMBER SIZING: The framing is 2" x 4" wood members.

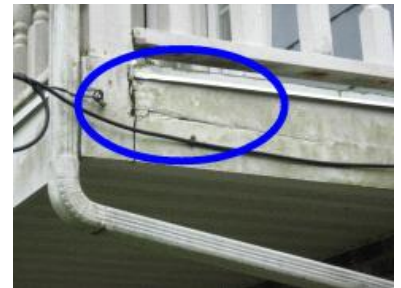
MATERIAL: Wood eaves and trim, wood door jambs and door trim.
CONDITION: **Generally OK but there is some minor wood rot to the trim board on the east end of the front porch's balcony -see photo. Always refer to the WDO (wood destroying organism) report issued by the Pest Inspection Company for the complete list of locations of all of the wood rot and/or termite damage. We recommend that any wood repair work not begin before their list is issued.**

Generally OK but there is some minor wood rot to the trim board on the east end of the front porch's balcony -see photo. Always refer to the WDO (wood destroying organism) report issued by the Pest Inspection Company for the complete list of locations of all of the wood rot and/or termite damage. We recommend that any wood repair work not begin before their list is issued.

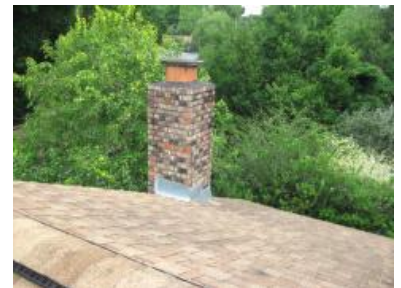
MATERIAL: Brick.
CONDITION: OK, the brick is in good condition and the concrete cap is secure.

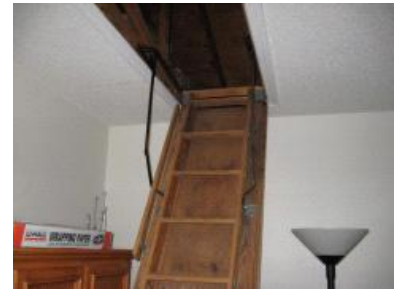
ATTIC ACCESS LOCATION: Ceiling.

The attic is somewhat accessible, ventilation is provided, and its visible general conditions are OK.

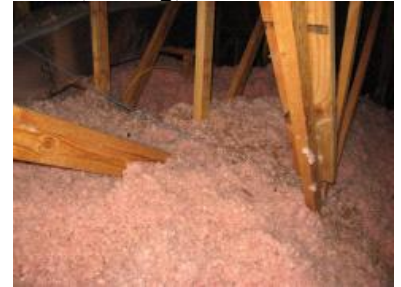
Batts & blown - OK.

DEPTH AND R-FACTOR: 12-16 +/- inches = R-38 +/-.

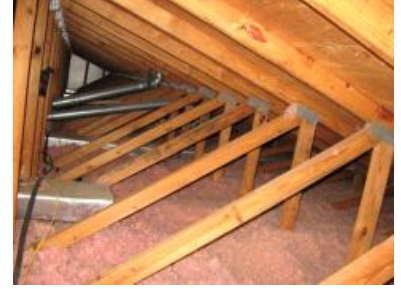
ROOF FRAMING: A combination of truss and site built framing using 2 X 4 and/or larger material.

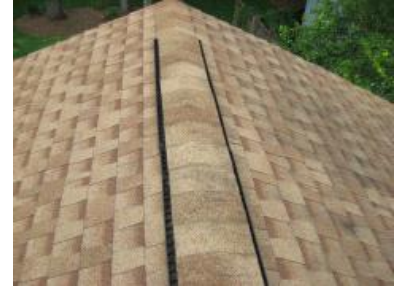
SLOPE: Medium.
ROOF ACCESS: I walked on the roof.
ROOF COVERING STATUS: The roof which is a 2004 installation appears OK. The current general conditions are good and serviceable with signs of normal weathering and aging. Regular maintenance and inspections are advised.

ESTIMATED LIFE EXPECTANCY OF ROOF: The roof covering material has an **estimated** remaining life expectancy of 12 +/- years, assuming proper maintenance is completed as needed. **NOTE: The life expectancy given is the best estimate of the inspector, assuming proper maintenance. The actual life of the roofing materials used can be influenced by external sources like weather extremes, conditions caused by trees and vegetation, and mechanical damages.**

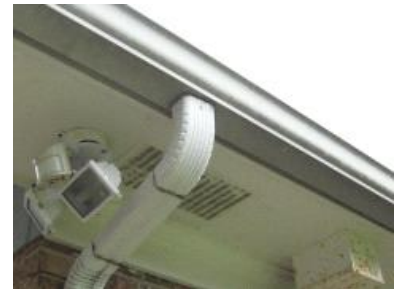
GUTTERS & DOWNSPOUTS:
TYPE & CONDITION: Metal, partial coverage, overall general condition is OK.

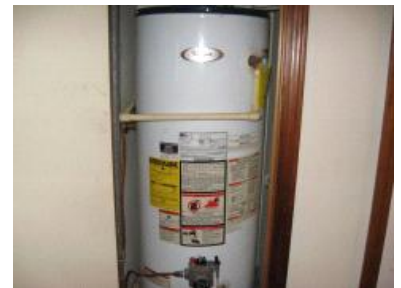
TYPE: Gas.
SIZE: 40 Gallons.

AGE: The water heater was manufactured in 2009 (approx. age taken from the unit's data plate).

CONDITION: Operational at this time, hot water is being produced.

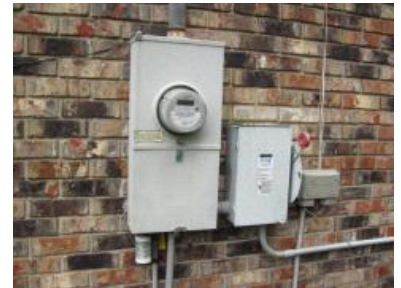
TYPE: Overhead / 110/220 Volt with circuit breakers.

MAIN PANEL POWER SIZE: 200 amp +/- . The ampacity of the main service panel is adequate for the structure as it is presently being used.

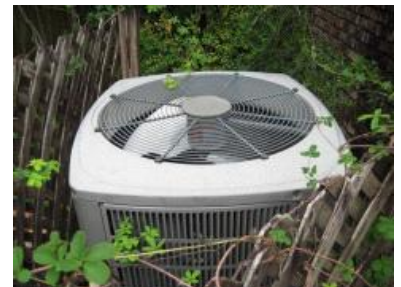
TYPE: Central electric.
POWER SOURCE: 220 Volt, electrical disconnect present.
MAKE/MODEL/SERIAL: Goodman / G042 / 2008.

EXTERIOR COMPRESSOR/CONDENSER AGE & INTERIOR COIL/AIR: Exterior and interior units were built in 2008. Manufacturing ages are taken from the unit's data plate. The exterior unit typically lasts 12-15 years with proper maintenance.

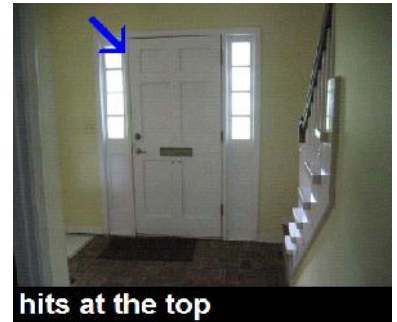
The front door operates and locks OK however the doorbell does not work and the door hits a little at the top.

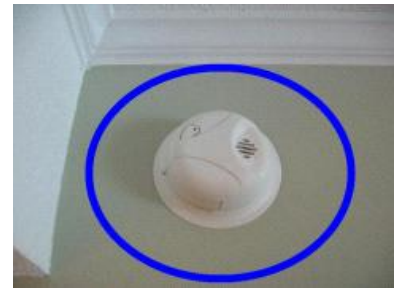
CONDITION: **The downstairs smoke alarm failed to operate while the upstairs smoke alarm responded to the test button operation.**
Because there is a gas item (water heater) in the house and/or garage, it is recommended to install carbon monoxide detectors per manufacturers specifications.

The downstairs smoke alarm failed to operate while the upstairs smoke alarm responded to the test button operation.

Because there is a gas item (water heater) in the house and/or garage, it is recommended to install carbon monoxide detectors per manufacturers specifications.

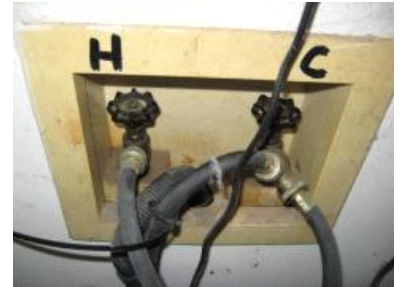
CONDITION: Plumbing is OK / serviceable. 220 Service is operative (older three (3) prong outlet noted, new dryers use a four (4) prong outlet). Dryer venting is provided. **As part of routine maintenance, it is advised to keep the vent clean and free of lint and debris.**

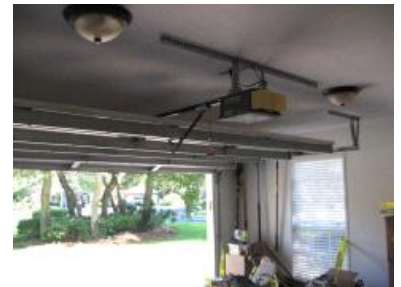
CONDITION: The garage door is working and serviceable, the automatic door opener works properly, and the automatic reverse feature is operational.
